The behavior of rehabilitee beam-column joint under repeated load

Abstract: This study aims to examine three kinds of rehabilitation techniques which are Carbon Fiber Reinforced Polymer “CFRP” Internal sheets, CFRP jacketing, and Slurry infiltrated Fiber Concrete “SIFCON” jacketing. The experimental program involved casting six specimens of R.C beam-column joints. These specimens are rehabilitated by the proposed techniques and retested. Three of these specimens are rehabilitated by SIFCON jacketing with different levels of jacket thickness and steel fibers. All the specimens (before and after rehabilitation) were tested under the repeated load of three cycles every 400 kN till failure. The specimens consisted of beam and column of 600mm and the joint area is 400mm by 400mm. The results showed that all the techniques were efficient in the recovery of the original structural properties of R.C joints. The CFRP internal sheets recover 144.49 % of maximum strength and 141.57% for yielding load while CFRP jacketing recovers 142.86% and 189.87%. While the SIFCON jacketing recovers about 170.71% to 188.14% of maximum strength and about 214.15% to 249.71% to 226.58% of yielding load respe

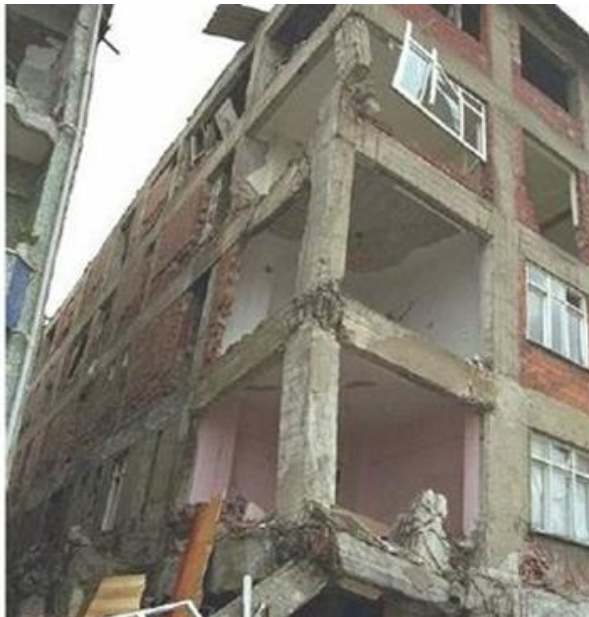
Figure 1: Severe damage (semi collapse) in beam-column connections after the 1999 Izmit, Turkey earthquake [2]

Although buildings designed and constructed in accordance with the known seismic standards are capable to withstand the applied seismic forces, this fact does not exist for old exhausted buildings. Exploration reports of recent earthquakes are always revealing the vulnerability of older existing RC buildings [1]. However, when beam-column joints were severely damaged, in many cases observed or reported building failures may be happening as shown in Figure 1.

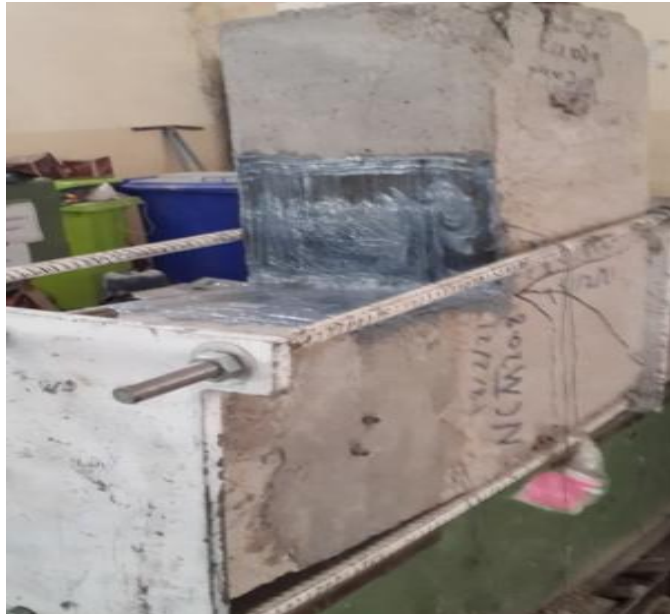
Figure 5: Internal CFRP sheet specimen

Figure 4 and Figure 5 show such technique. Before applying any procedure for rehabilitation, the rehabilitated specimen's cracks were diagonal in the joint zone formed by axial load and then the repairing process began, cleaning by an air compressor and then filled with Epoxy for all proposed techniques. The Internal CFRP Sheets have 30 cm L shape sheets of CFRP after adding two layers of Epoxy at the intended surface and left for 7 days to gain reasonable strength.

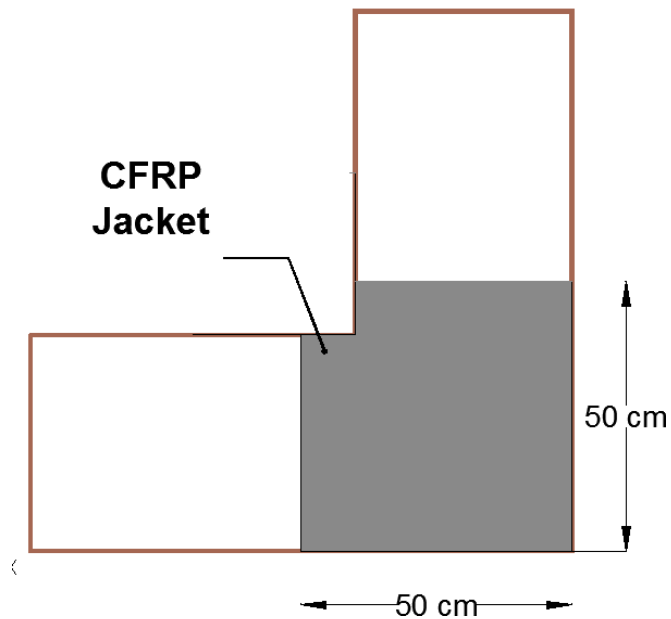
Figure 6: The CFRP jacket

The CFRP jackets which have been proposed in this research program are covering the joint zone as well as an extended 10 cm within beam and column as shown in Figure 6 and Figure 7. As in the previous technique, two layers of Epoxy were added to the intended surface and left for 7 days to gain reasonable strength.

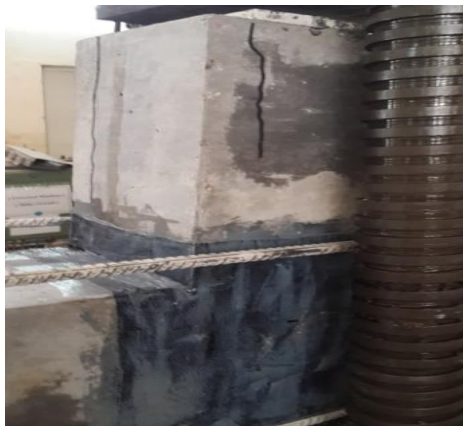
Figure 7: The CFRP jacket specimen

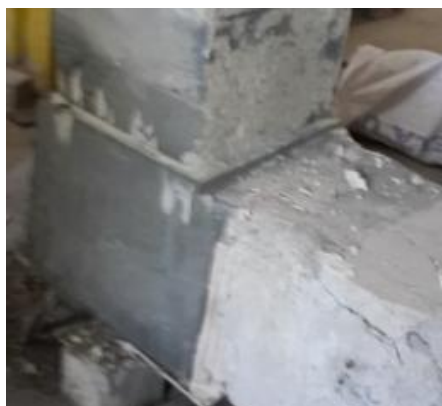
Figure 9: The SIFCON jacket specimen

The 50 cm SIFCON jacket was casted to cover all the joint area and extended to 10 cm with beam and column of each specimen. The time of casting SIFCON jackets was calibrated to get 28 day until testing. Furthermore, twelve 5 mm in diameter was bolted through the joint zone of the rehabilitated specimens as shown in Figure 8 and Figure 9. Three specimens were rehabilitated by this technique to calculate two thickness values as well as two amounts of steel fibers, as illustrated previously.

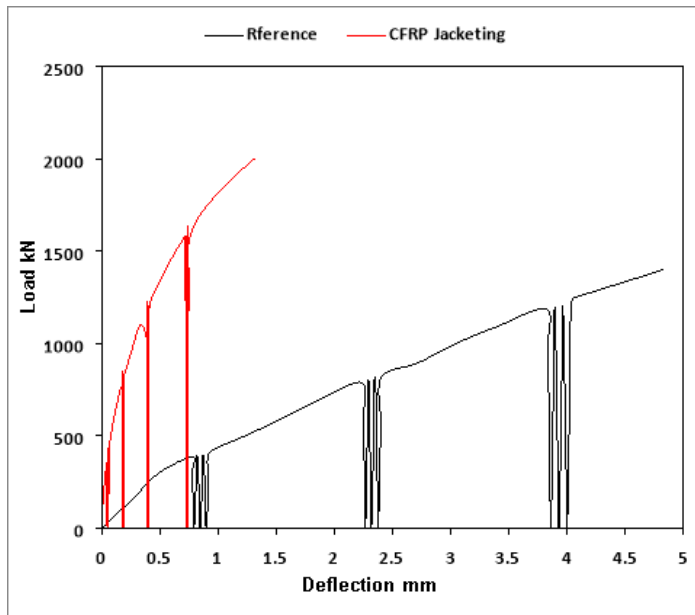
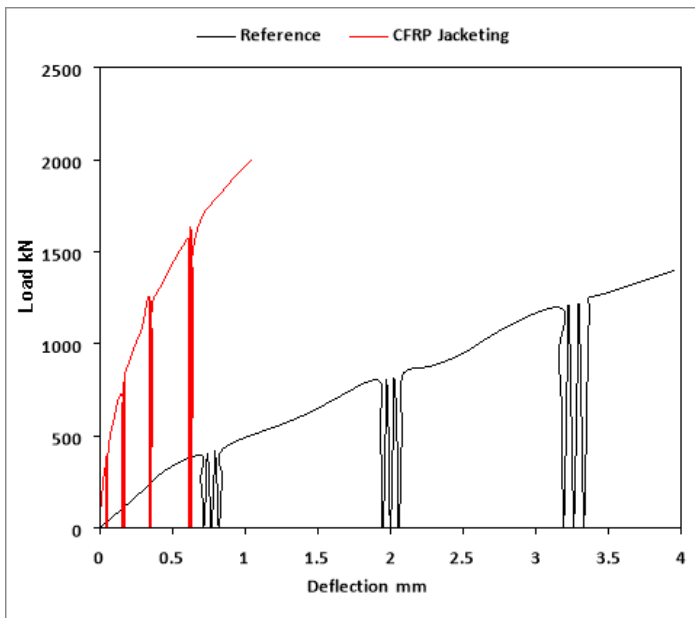
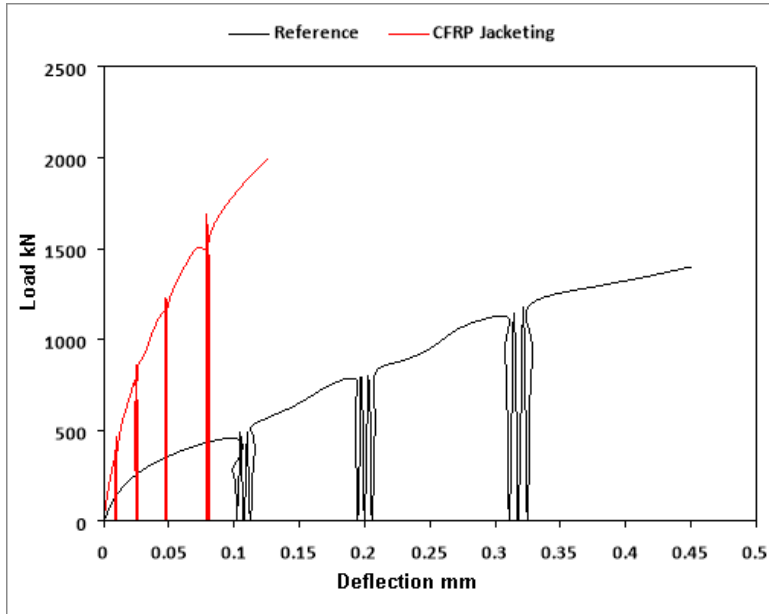
Figure 10: Load deflection curves of CFRP jacketing DCR

Figure 11: Load deflection curves of CFRP jacketing DBR

Figure 12: Load deflection curves of CFRP jacketing DCL

Figure 13: Load deflection curves of CFRP jacketing DCD

Table 2 shows the maximum strength, yielding strength. Figures 10 to 13 highlight the load deflection curves. Where: deflection in column right direction (denoted as DCR), deflection in beam right direction (denoted as DBR), and deflection in column left direction (Denoted as DCL) and deflection in column downward direction (denoted as DCD).

On average, the results presented in Table (2) show that the recovery is 142.86 % and 189.87 % for maximum load and yielding load respectively. Together these degrees of recovery with CFRP internal sheets, CFRP jacketing proved more level of performance. These results can be explained by the fact that the jacketing play the role of enhancement in two possible ways, the first is the resisting components of CFRP and epoxy along the surface of failure (as in CFRP internal sheets technique) and the second is the confinement action of CFRP.

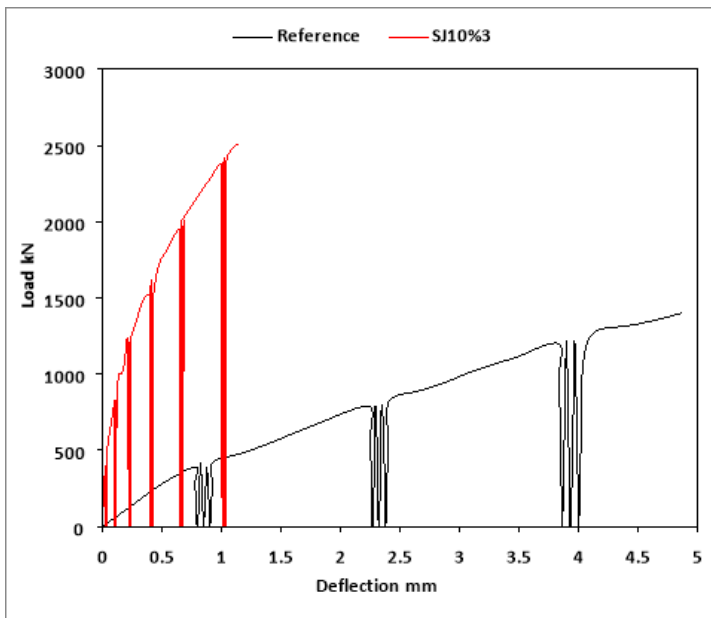
Figure 14: The load deflection curve DCR

Figure 15: The load deflection curve DBR

Figure 16: The load deflection curve DCL

Figure 17: The load deflection curve DCD

With respect to maximum Strength, Yielding Strength, Maximum Deflection and Yielding Deflection, Table 4 shows the maximum strength, yielding strength, maximum deflection. Figure 14, 15, 16, and 17 show the load deflection curves.

As Table 4 shows, there is a significant degree of recovery in load carrying capacity as well as the yielding load when SIFCON jacketing was used with 10% steel fibers and 3cm jackets thickness. The load carrying capacity recovery has reached 179.64% while the yielding load recovery has reached 226.58%. There are, however, possible explanations for these results. This can be presented by the interference between the new cement past and the RC joint where this paste can be infiltrated between the concrete fragments, the high strength of SIFCON (due to the presence of steel fibers) as well as to the enhancement role of steel bolting which can also play a major share in this jump of capacity.
